Fire resistance test report

Penetration systems tested in accordance with AS 1530.4:2014

Products: Allproof ALLFC25Galv fire collar and Bostik Firecaulk sealant

Job number: FRT190057 Test number: FRT180434

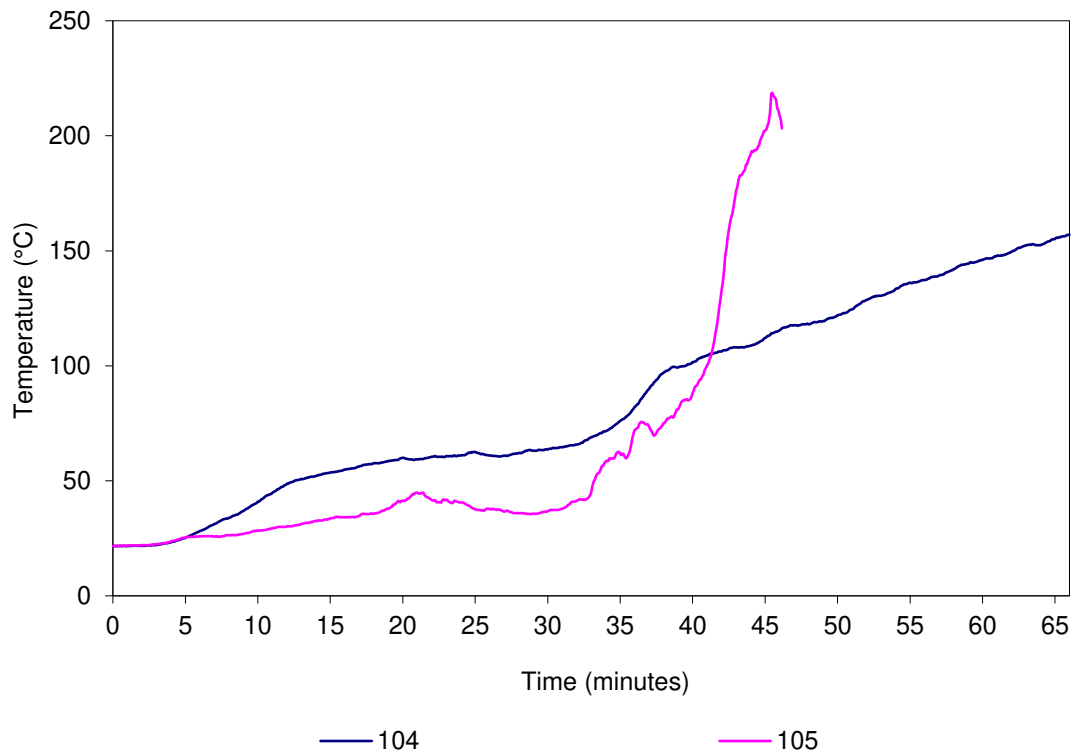
Figure 17 Penetration system F – temperature vs time (TC105 detached after the 46 minute period)

44	55	TC 105 on the service, 25mm from the fire collar recorded a temperature of 202°C. Failure of insulation in accordance with AS 1530.4:2014 clause 2.13.3(b), where the maximum temperature of Thermocouple TC 105 exceeded the initial temperature by more than 180K.
46	02	Service has further deformed near the fire collar.
50	42	Smoke emitting from the fire collar and aperture.

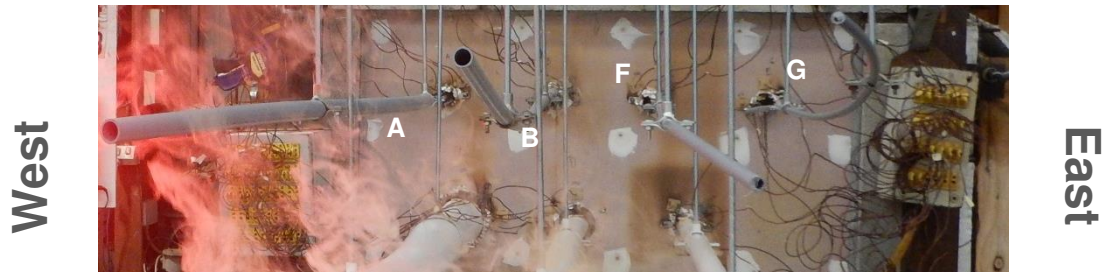
Figure 22 Unexposed face of specimen at the end of test

30	00	Specimen continued to maintain integrity and insulation in accordance with AS 1530.4:2014.
50	42	Smoke emitting from the fire collar and aperture.
57	33	Plasterboard has discoloured below mid-height of the separating element.
57	50	TC 021 on the separating element, 25mm from the fire collar recorded a temperature of 202°C. Failure of insulation in accordance with AS 1530.4:2014 clause 2.13.3(b), where the maximum temperature of Thermocouple TC 021 exceeded the initial temperature by more than 180K.
60	00	Specimen continued to maintain integrity in accordance with AS 1530.4:2014.
66	00	Test terminated at the request of the sponsor.
Penetration system F		
00	00	Fire resistance test commenced, and the initial temperature of the specimen was approximately 22°C.
30	00	Specimen continued to maintain integrity and insulation in accordance with AS 1530.4:2014.
38	09	Service has deformed near the fire collar.
